# Manhole Inspection Summary

Manhole # S13EE2033MH

**Location** Address: **2114 WESTERN RUN DR**

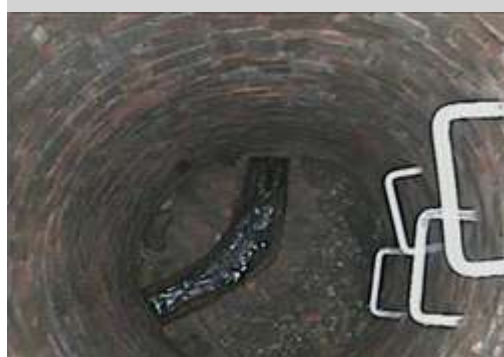
Top View

**Surcharge** ☒ **Evidence Of Surcharge** Depth: **1** (ft.) ☐ Active Surcharge Present

Evidence of surcharge - Bench debris.

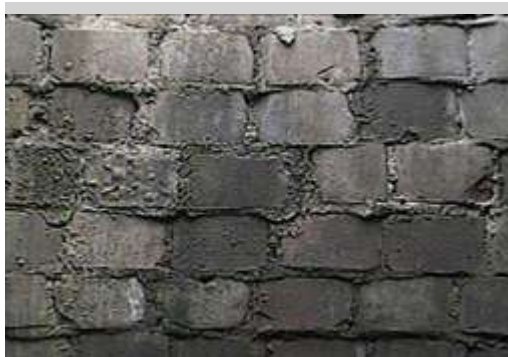
Defect

Infiltration: ☐ None ☐ Joint ☐ Cracks ☒ **Mortar** ☐ Roots ☒ **Wall**

Corbel infiltration.

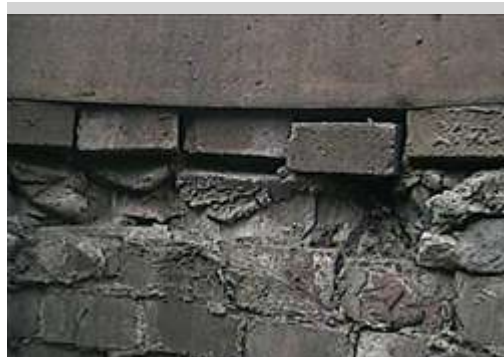
Defect

**Frame** Offset: **0** (in.) Condition: ☐ Sound ☐ Cracked ☒ **Leaks**

Condition: ☐ Sound ☐ Cracked ☐ Root Intrusion ☒ **Loose Brick** ☒ **Deteriorated**

Infiltration: ☐ None ☒ **Joint** ☐ Cracks ☒ **Mortar** ☐ Roots ☐ Wall

Frame leaks. Adjustment deterioration, loose brick, and infiltration.

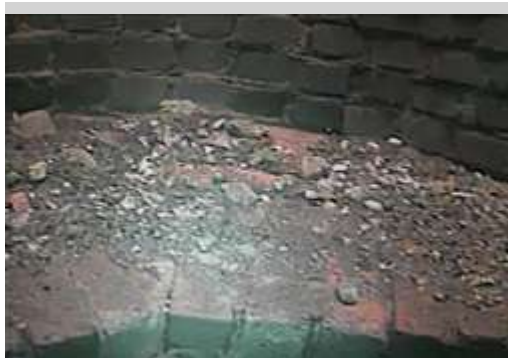
Defect

**Bench** ☒ Exists Material: **Brick** ☐ Parged ☒ **Debris** (not Condition related)

Bench debris.

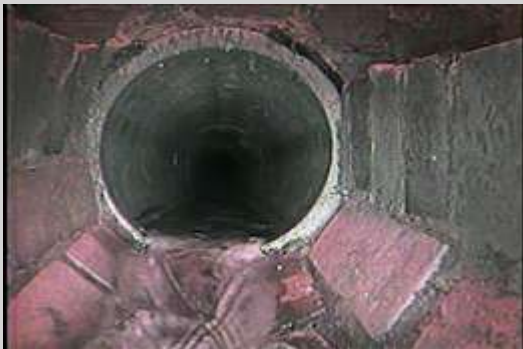
### 8 in. Circular Gravity Sewer Pipe In @ 8 O'Clock

Comments **The I8 pipe seal is not flush to the pipe.**

Infiltration: **Evidence** Pipe Seal Cond: **Unknown**
